MYANMAR

General

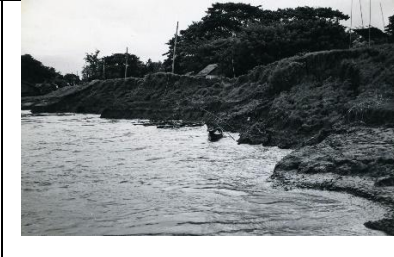
<p>A2 001/IX.2.1 Map of Pagan and surroundings along the Irrawaddy, October 1970</p>	<p>A2 001/D1.II.1 Boat, presumably at one of the branches of the Irrawaddy River, 1977</p>	<p>A2 002/D1.II.2 Boat, presumably at one of the branches of the Irrawaddy River, 1977</p>	<p>A2 003/D1.II.3 Bank erosion, presumably along one of the branches of the Irrawaddy River, 1977</p>

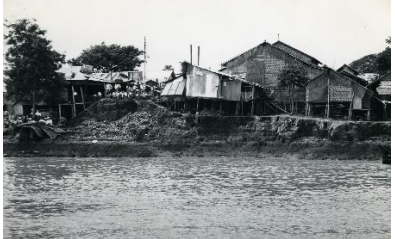
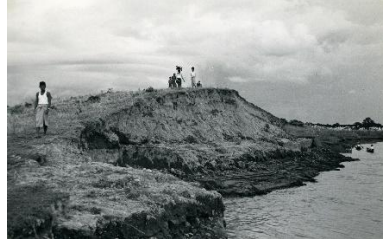
<p>A2 004/D1.II.4 Bank erosion, presumably along one of the branches of the Irrawaddy River, 1977</p>	<p>A2 005/D1.II.5 Bank erosion, presumably along one of the branches of the Irrawaddy River, 1977</p>	<p>A2 007/D1.II.7 Traditional boats, presumably at one of the branches of the Irrawaddy River, 1977</p>	<p>A2 008/D1.II.8 Traditional boats, presumably at one of the branches of the Irrawaddy River, 1977</p>

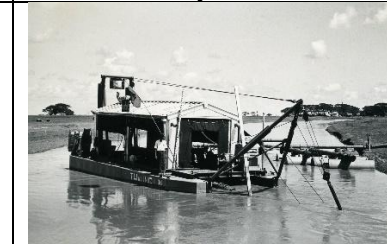
<p>A2 021/D1.II.21 Traditional boats, presumably at one of the branches of the Irrawaddy River, 1977</p>	<p>A2 022/D1.II.22 Settlement, presumably along one of the branches of the Irrawaddy River, 1977</p>	<p>A2 023/D1.II.23 Traditional boats, presumably at one of the branches of the Irrawaddy River, 1977</p>	<p>A2 024/D1.II.24 Dredging work, presumably at one of the branches of the Irrawaddy River, 1977</p>

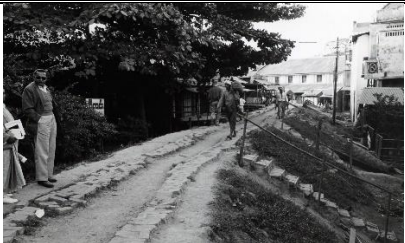
<p>A2 033/D1.II.33 Aerial picture lowland area, presumably along one of the branches of the Irrawaddy River, 1977</p>	<p>A2 034/D1.II.34 Irrawaddy Delta, bank erosion near Henzada threatening a dike that protects the town. To be prepared for a possible failure, a set back dike has been built to serve as a second line of defence, 1977</p>	<p>A2 035/D1.II.35 Dike in Henzada, 1977</p>	<p>A2 036/D1.II.36 Buildings possibly at and behind a dike in Henzada, 1977</p>
