SOUTH KOREA

General

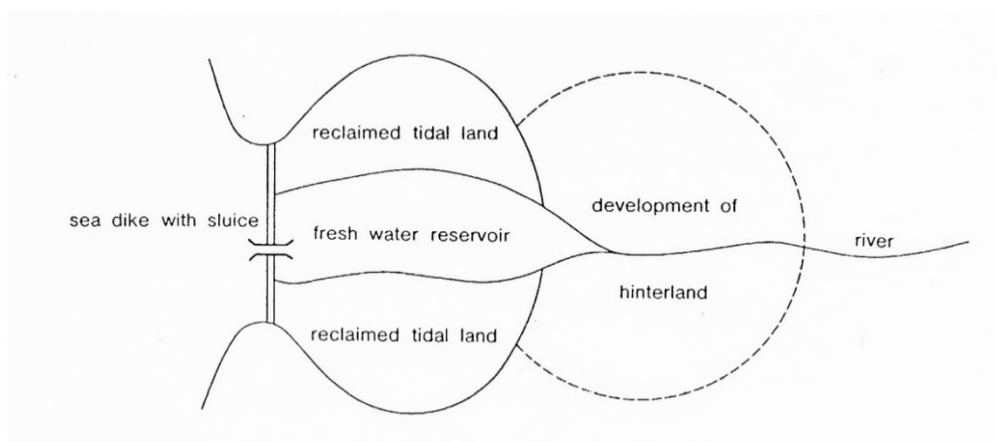
Figure 2. Schematic presentation of tidal land reclamation schemes in South Korea (IJsselmeerpolders Development Authority, 1985)

Sang-Hyun Park *et al.* (2018) present the tidal land reclamation schemes in South Korea (Figure 1). A schematic presentation of the tidal land reclamation schemes is shown in Figure 2 (IJsselmeerpolders Development Authority, 1985).

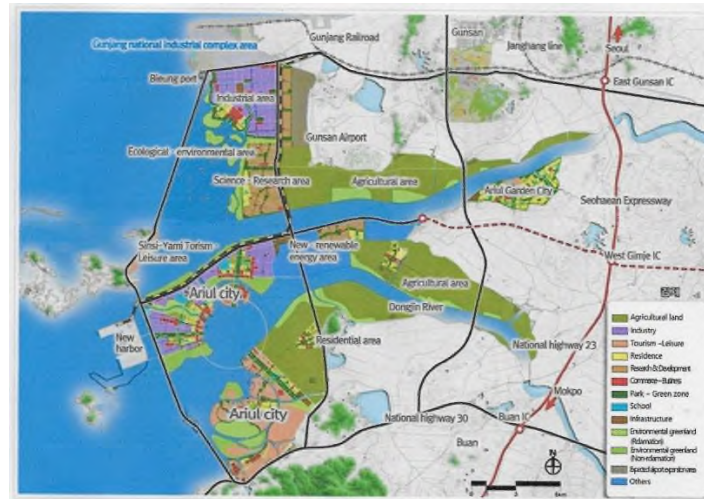
Figure 3. Land use plan of the Saemangeum Coastal Reclamation Project (Moonsoo Cho *et al.*, 2016)

Under development is the Saemangeum Coastal Reclamation Project. This project includes the largest sea dike in the world (33 km) reclamation of 28,300 ha coastal and foreshore area and the creation of a fresh water lake of 11,800 ha (Figure 3) (Moonsoo Cho *et al.*, 2016).

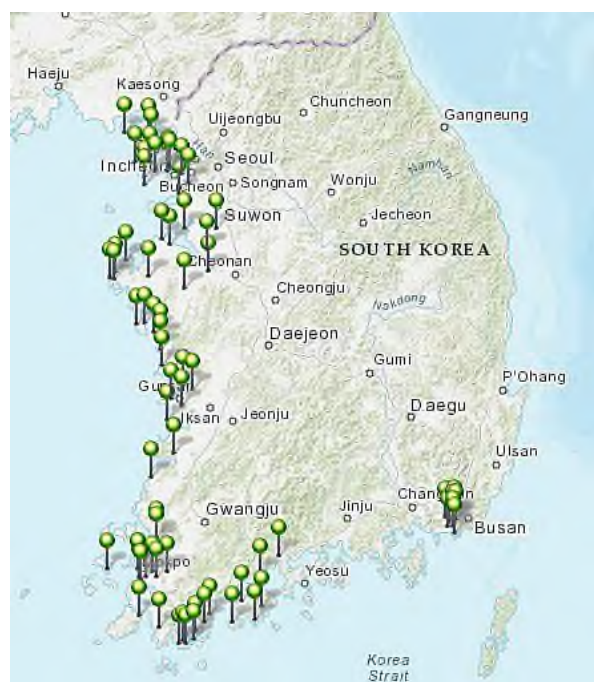
Figure 4. Location of the polders in South Korea (source: esri – Batavialand)

The location of the polders in South Korea is shown in Figure 4.

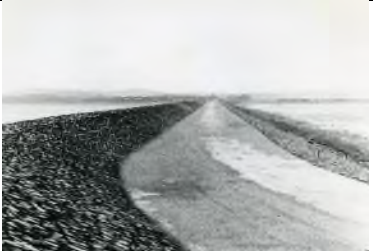
<p>A3 001/XI.3.1 Prof. Adriaan Volker right at the group picture 27 July 1964</p>	<p>A2 064/I.2.64*) Enslosing Dam of Nam Yang for land reclamation and fresh water supply. Inaugurated May 1974, 1974</p>	<p>A5 001/XI.5.1 Polder area, probably near Pusan, 1974</p>	<p>A5 002/XI.5.2 Polder area near Mokpo. Probably dike construction by rail, 1974</p>

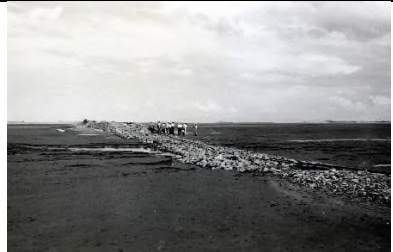
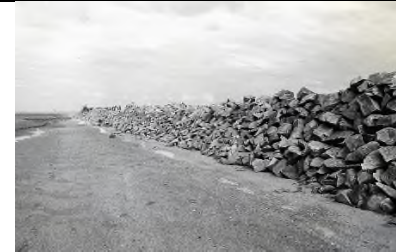
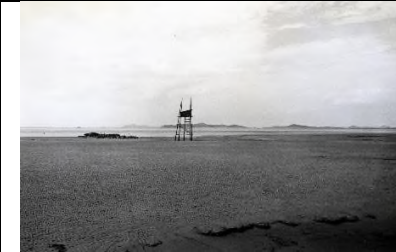
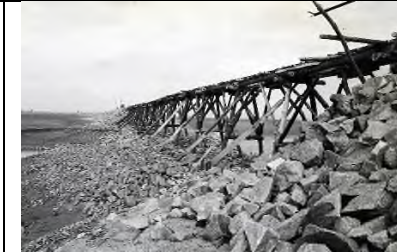
A5 011/XI.5.11 Dongjingang Tidal Country. Railway for dike construction, 1974	A5 012/XI.5.12 Dongjingang Tidal Country. Railway for dike construction, 1974	A5 013/XI.5.13 Dongjingang Tidal Country. Stone dike under construction, 1974	A5 014/XI.5.14 Dongjingang Tidal Country. Temporary railway bridge for dike construction, 1974

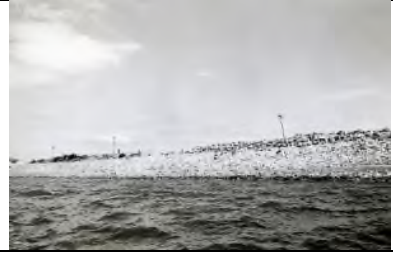
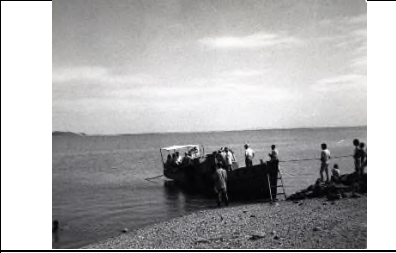
A5 019/XI.5.19 Dongjingang Tidal Country. Temporary railway bridge for dike construction, 1974	A5 020/XI.5.20 Dongjingang Tidal Country. Temporary railway bridge for dike construction, 1974	A5 021/XI.5.21 Dongjingang Tidal Country, 1974	A5 022/XI.5.22 Dongjingang Tidal Country. Dike construction, 1974

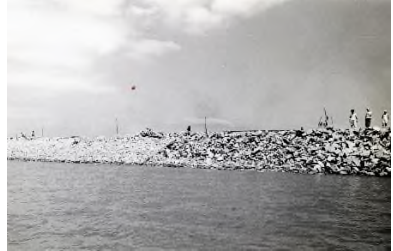
A5 023/XI.5.23 Dongjingang Tidal Country. Dike construction, 1974	A5 024/XI.5.24 Ansong Chon Estuary, 1974	A5 025/XI.5.25 Ansong Chon Estuary, 1974	A5 026/XI.5.26 Ansong Chon Estuary, 1974

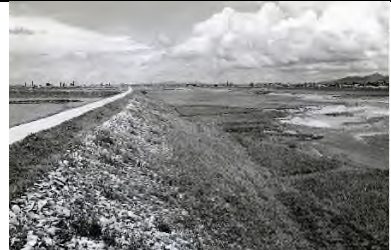
A5 032/XI.5.32 Ansong Chon Estuary, 1974	A5 033/XI.5.33 Ansong Chon Estuary, 1974	A5 034/XI.5.34 Ansong Chon Estuary, 1974	A5 035/XI.5.35 Dike in Sapkyo Chon area

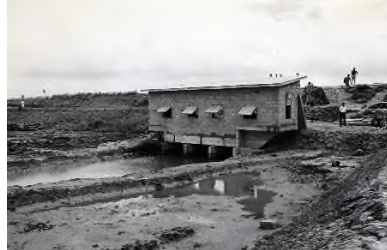
A5 044/XI.5.44 Kanghwa pilot area, 1974	A5 045/XI.5.45 Kanghwa pilot area, 1974	A5 046/XI.5.46 Pumping station in Kanghwa pilot area, 1974	A5 047/XI.5.47 Kanghwa pilot area, 1974

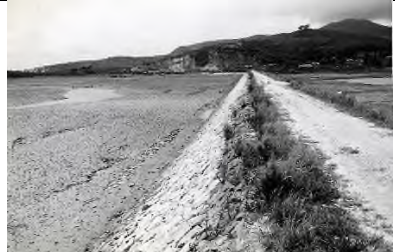
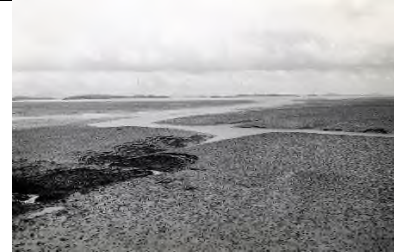
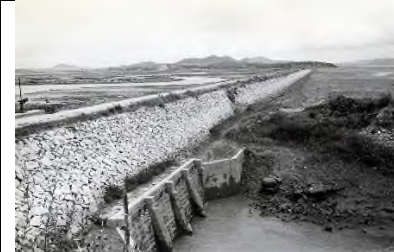
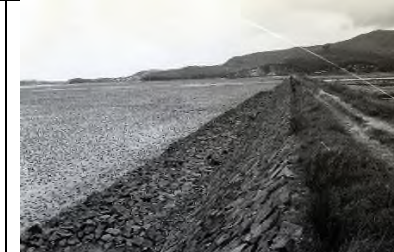
A5 048/XI.5.48 Sea dike in Kanghwa pilot area, 1974	A5 049/XI.5.49 Sea dike in Kanghwa pilot area, 1974	A5 050/XI.5.50 Sea dike in Kanghwa pilot area, 1974	A5 051/XI.5.51 Sea dike in Kanghwa pilot area, 1974

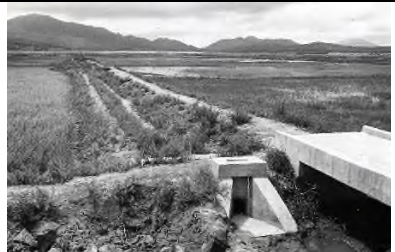
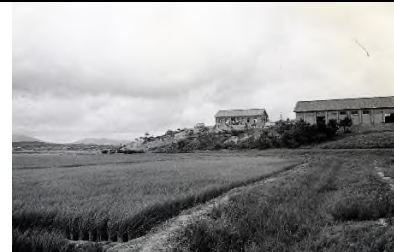
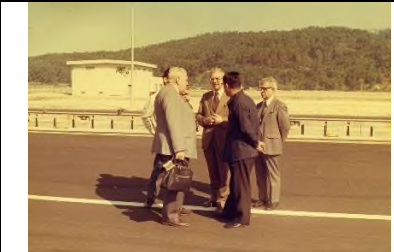
A5 052/XI.5.52 Sea dike in Kanghwa pilot area, 1974	A5 053/XI.5.53 Sea dike in Kanghwa pilot area, 1974	A5 054/XI.5.54 Sea dike and reclaimed land in Kanghwa pilot area, 1974	A5 055/XI.5.55 Kanghwa pilot area, 1974

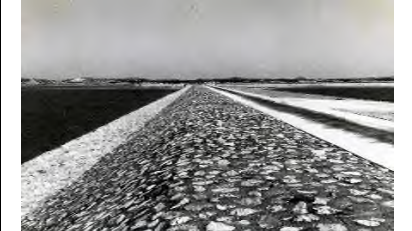
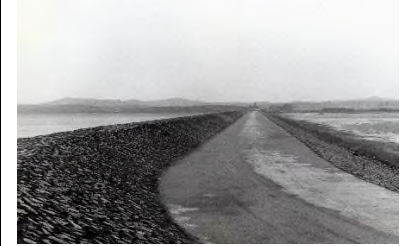
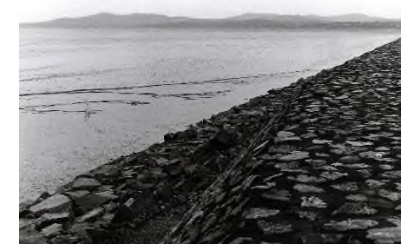
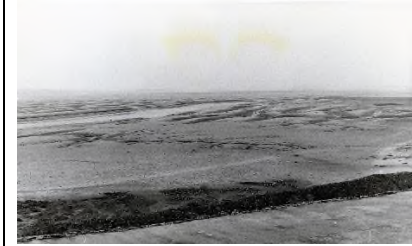
<p>A5 064/XI.5.64 Sea dike, 1974</p>	<p>A5 065/XI.5.65 Card of the Agricultural Development Corporation with the Nam Yang Sea dike. Completed in May 1974, 1974</p>	<p>A5 065A/XI.5.65A Card of the Agricultural Development Corporation with the Nam Yang Sea dike. Completed in May 1974, 1974</p>	<p>A5 066/XI.5.66 Nam Yang Sea dike, 1974</p>

<p>A5 067/XI.5.67 Nam Yang Sea dike, 1974</p>	<p>A5 068/XI.5.68 Nam Yang Sea dike, 1974</p>	<p>A5 070/XI.5.70 Nam Yang Tidal Flats, 1974</p>	<p>A5 071/XI.5.71 Nam Yang Tidal Flats, 1974</p>

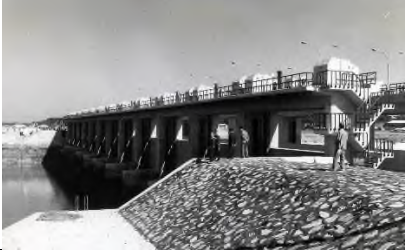
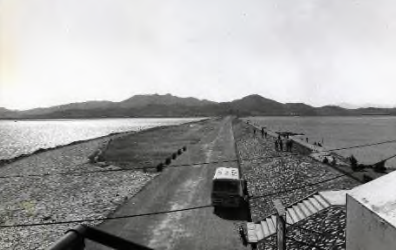
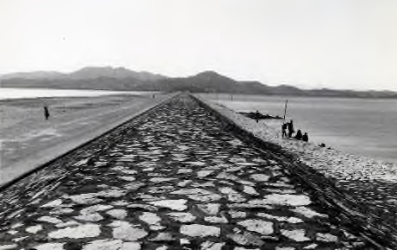
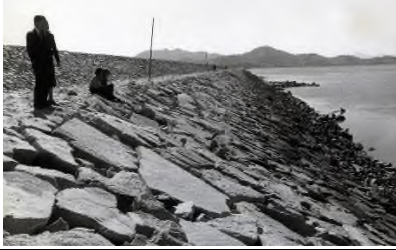
<p>A5 103/XI.5.103 Discharge sluice Anchong Song near Asan Bay, 1974</p>	<p>A5 104/XI.5.104 Sea dike closing of Asan Bay, 1974</p>	<p>A5 105/XI.5.105 Sea dike closing of Asan Bay, 1974</p>	<p>A5 106/XI.5.106 Sea dike closing of Asan Bay, 1974</p>

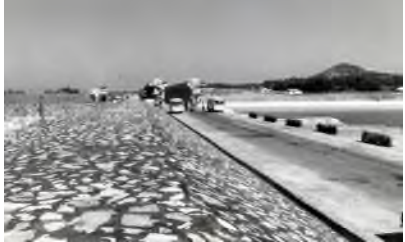
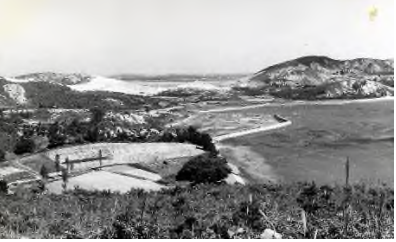
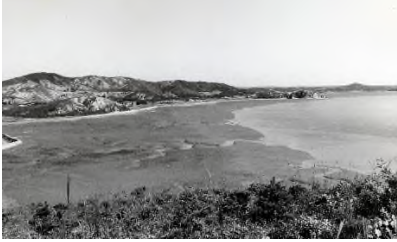
<p>A5 107/XI.5.107 Sea dike closing of Asan Bay, 1974</p>	<p>A5 108/XI.5.108 Overview Asan Bay with coastal polders, 1974</p>	<p>A5 109/XI.5.109 Overview Asan Bay with coastal polders, 1974</p>	<p>A5 110/XI.5.110 Group picture during an excursion of the International Symposium on Engineering Problems in Creating Coastal Industrial Sites. Prof. Adriaan Volker third from left, Prof. J.F. Agema third from right, 1974</p>

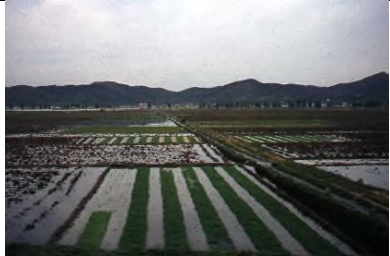
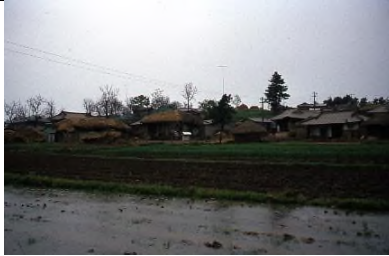
D1 3 024/D.1.3.24 Nursery of rice plants in a lowland area and possibly a polder	D1 3 025/D.1.3.25 Village presumably not in a polder	D1 3 026/D.1.3.26 View at a coastal polder	D1 3 027/D.1.3.27 Sea dike with discharge sluice

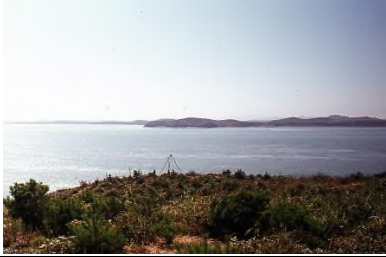
<p>D1 3 040/D.1.3.40 Overview of a sea dike under construction</p>	<p>D1 4 041/D.1.4.41 Bay</p>	<p>D1 4 042/D.1.4.42 Sea dike</p>	<p>D1 4 043/D.1.4.43 Shiplock</p>

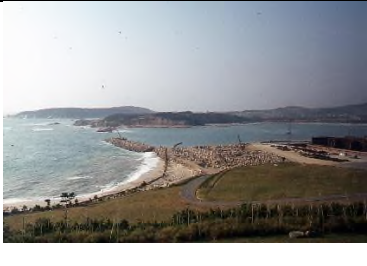
<p>D1 4 044/D.1.4.44 Shiplock</p>	<p>D1 4 045/D.1.4.45 Sea dike under construction</p>	<p>D1 4 046/D.1.4.46 Sea dike under construction</p>	<p>D1 4 047/D.1.4.47 Sea dike</p>

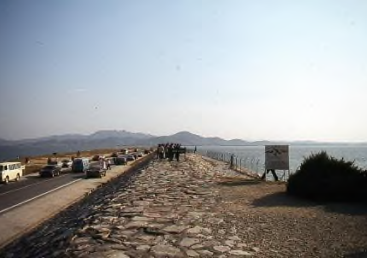
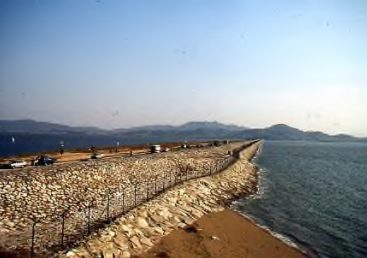
D2 4 009/IV-9 Sea dike of polders at the west coast, 6-27/10 1984	D2 4 010/IV-10 Sea dike of polders at the west coast, 6-27/10 1984	D2 4 011/IV-11 Information plate on polders at the west coast, 6-27/10 1984	D2 4 012/IV-12 Temple at a dike at the west coast, 6-27/10 1984

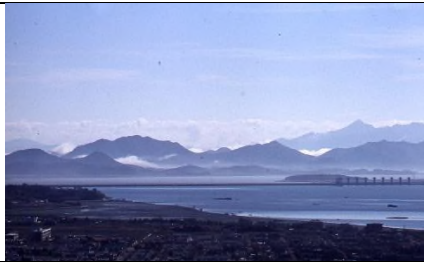
<p>D2 4 017/IV-17 Group picture at a touristic mountain near Mokpo. From left to right Gerard van Houweningen, Prof. van Duin - Dr. Kim, Ir. Han, Bart Schultz, 6-27/10 1984</p>	<p>D2 4 018/IV-18 Jongsanggang estuary dam in the morning fog at the west coast, 6-27/10 1984</p>	<p>D2 4 019/IV-19 Jongsanggang estuary dam in the morning fog at the west coast, 6-27/10 1984</p>	<p>D2 4 020/IV-20 Discharge sluices in the Jongsanggang estuary dam at the west coast, 6-27/10 1984</p>

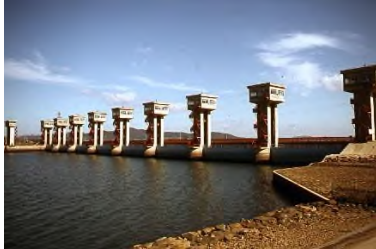
<p>D2 4 021/IV-21 Discharge sluices in the Jongsanggang estuary dam at the west coast, 6-27/10 1984</p>	<p>D2 4 022/IV-22 Tidal flats at low tide in front of the Jongsanggang estuary dam at the west coast, 6-27/10 1984</p>	<p>D2 4 023/IV-23 Information plate on the polders in the southwestern part of the west coast, 6-27/10 1984</p>	<p>D2 4 024/IV-24 Sea dike in a higher part of an estuary at the west coast, 6-27/10 1984</p>

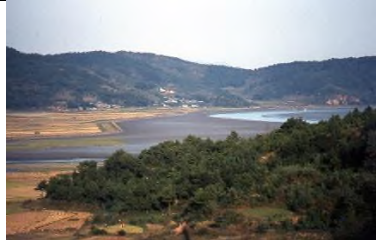
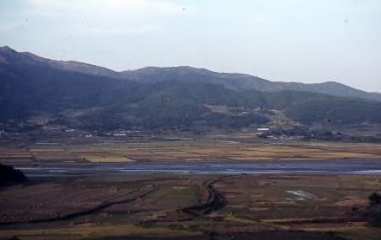
<p>D2 4 025/IV-25 Tidal flats at low tide in front of the Jongsanggang estuary dam at the west coast, 6-27/10 1984</p>	<p>D2 4 026/IV-26 Polders in the southwestern part of the west coast, 6-27/10 1984</p>	<p>D2 4 027/IV-27 Polders in the southwestern part of the west coast, 6-27/10 1984</p>	<p>D2 4 028/IV-28 Polders in the southwestern part of the west coast, 6-27/10 1984</p>

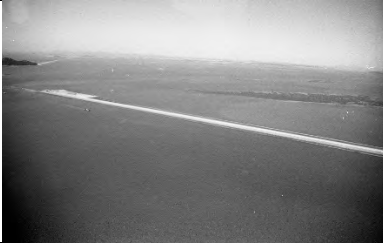
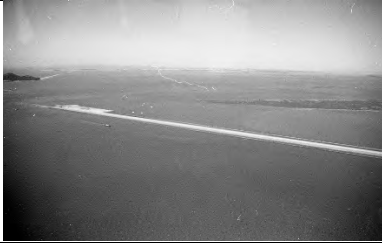
Row 3 002/XVI/3-2 Building pit for one of the discharge sluices in the sea dike of Saemangeum Coastal Reclamation Project, September 2001	Row 3 003/XVI/3-3 Building pit for one of the discharge sluices in the sea dike of Saemangeum Coastal Reclamation Project, September 2001	Row 3 004/XVI/3-4 Building pit for one of the discharge sluices in the sea dike of the Saemangeum Coastal Reclamation Project, September 2001	Row 4 001/XVI/4-1 Building pit for one of the discharge sluices in the sea dike of the Saemangeum Coastal Reclamation Project, September 2001

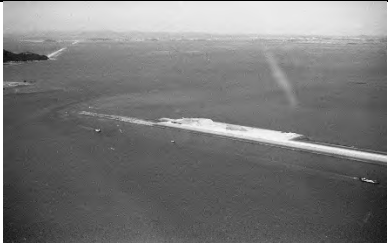
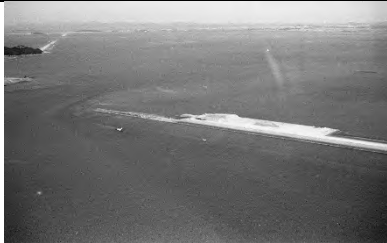
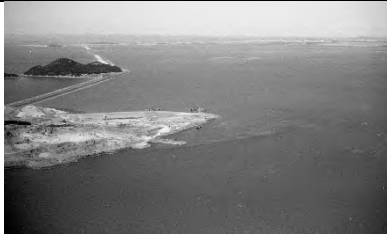
Row 4 002/XVI/4-2 Construction of the sea dike of the Saemangeum Coastal Reclamation Project, September 2001	Row 4 003/XVI/4-3 Construction of the sea dike of the Saemangeum Coastal Reclamation Project, September 2001	Row 4 004/XVI/4-4 Construction of the sea dike of the Saemangeum Coastal Reclamation Project, September 2001	Row 5 001/XVI/5-1 Construction of the sea dike of the Saemangeum Coastal Reclamation Project, September 2001

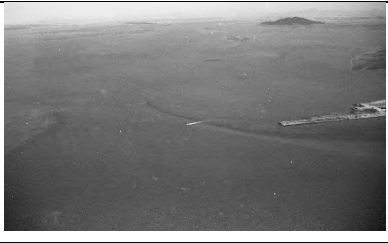
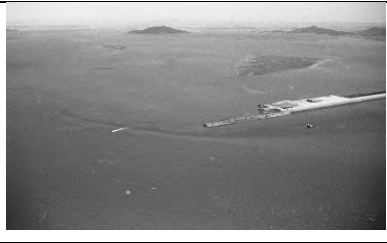
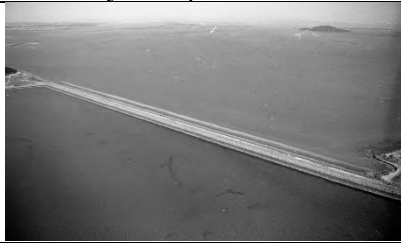
Row 5 002/XVI/5-2 Construction of the sea dike of the Saemangeum Coastal Reclamation Project, September 2001	Row 5 003/XVI/5-3 Construction of the sea dike of the Saemangeum Coastal Reclamation Project, September 2001	Row 5 004/XVI/5-4 Construction of the second and third dike section of the sea dike of the Saemangeum Coastal Reclamation Project, September 2001	Row 6 001/XVI/6-1 Construction of the second and third dike section of the sea dike of Saemangeum Coastal Reclamation Project, September 2001
